SSC Service Bulletin

no. 82-284

MODELS AFFECTED: MCPH251A, 256A, 401A, 406A, 601A, 606A

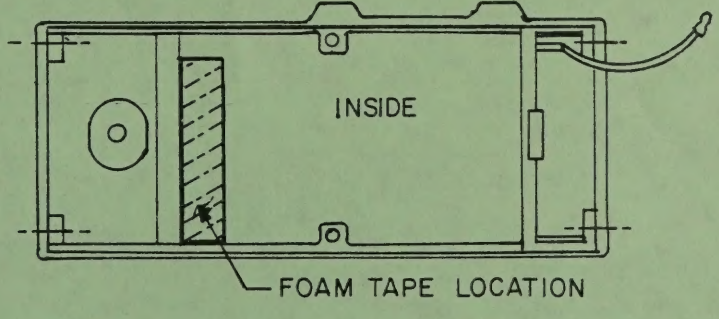
SYMPTOMS: LOSS OF RECEIVER SENSITIVITY

CAUSE: FAILURE OF R-4 AND/OR C-10 DUE TO VIBRATION OF P.C. BOARD

Attach poly foam tape to inside rear case as shown:
